**Project Description.** Completing this project will reduce impacts to the natural processes of the Toklat River, alleviate damage to the riverbank and adjacent park facilities, minimize maintenance of the causeway, enhance the visitor experience, and reduce yearly costs associated with emergency maintenance measures to keep the road and rest stop passable.

## Mega-Project\* Profile: Name of Project

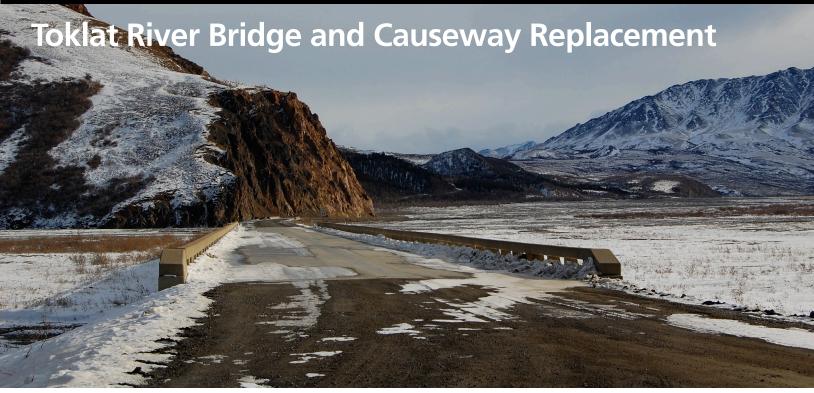
Above: The East Bridge of the Tolkat River crossing on the Denali Park Road. (Photo by John Seibert.)

Since 2005 all the surface flow has been conveyed under the east bridge span. An artificial constriction like the causeway will change the river dynamics, and commonly observed

posit is readily visible downstream of the east bridge of the causeway.
